S.I.L. NO. 01-560-06

SERVICE INFORMATION LETTER

FROM: JetProp LLC

SUBJECT: JetProp Inlet Fixed Turning Vane Drain Holes

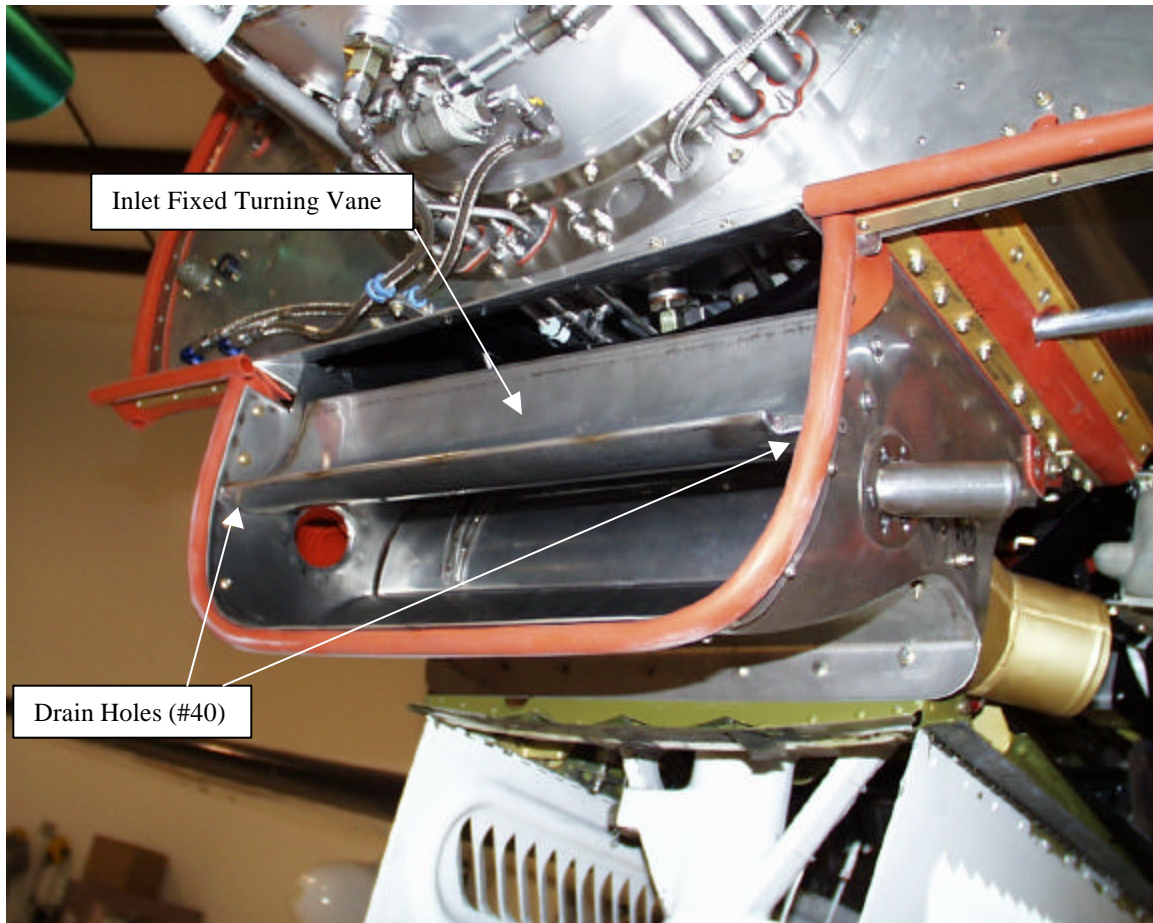
Figure 1. Fixed Turning Vane Drain Holes

During a recent upgrade of an early JetProp conversion, we discovered some corrosion to the nut plates in the inlet fixed turning vane. Therefore, to prevent water vapor from collecting in the fixed turning vane we recommend adding two #40 (.098 inch) drain holes in the bottom of the fixed turning vane as shown in Figures 1 and 2 in Attachment 1. This action should be accomplished at the next maintenance action/inspection requiring the removal of the bottom cowling. With the bottom cowling removed the fixed turning vane can easily be removed for easy access to drill the drain holes. If there are any questions, please contact Rich Runyon in Engineering or Curtis Vandegriffe the chief of maintenance at (509) 535-4401.

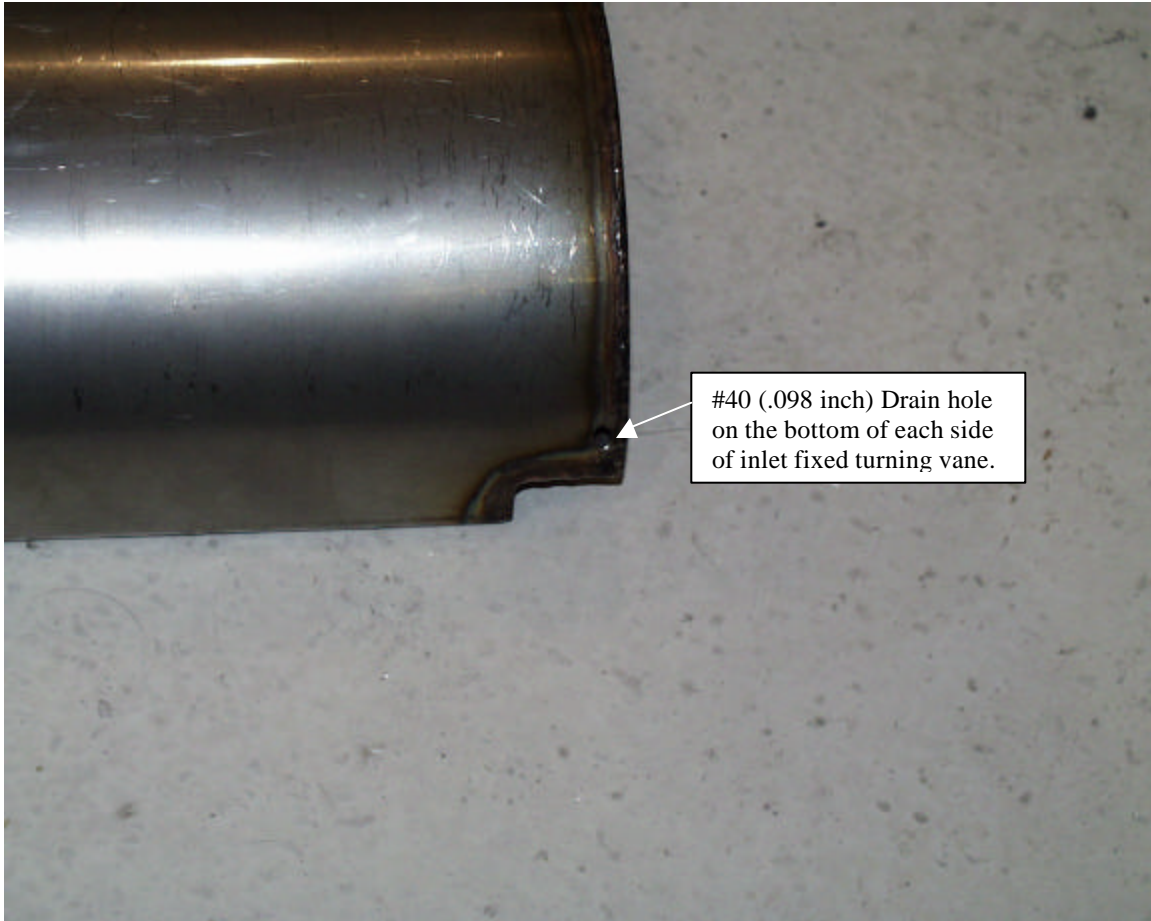
Figure 2. Location of Fixed Turning Vane Drain Holes
